**Flood Control Project Maintenance  
Levee Inspections**  
**LMA District Cover Sheet**  
**Spring 2017 Levee Inspection Results**

**Reclamation District No. 0556 Upper Andrus**

**Levee Inspection Report By Mile - Spring 2017**

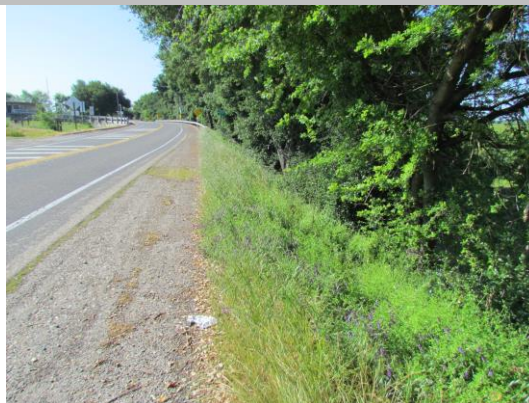
Photo 1 of 1 : SP\_2017\_RD0556\_18\_21\_20170517\_00053.jpg

LM Start	0.09	Rating **	U	Issue No.	21
LM End	0.90	Issue Type +	Ma	Location *	LS
Category	Earthen Levee			GPS Latitude/Longitude	
				Start	End
Item	Vegetation			38.237863 °	38.228602 °
				-121.518163 °	-121.526290 °
DWR ID	DWR_RD0556_01_s_2017_21				
Comment Code					
V7 : Trees / Woody Vegetation					
Inspector Comment					
Control the wild growth and trim the trees so the slope can be seen.

Looking downstream from levee mile 0.09 woody tree growth and wild weeds covering the levee slope and shoulder landside levee section.

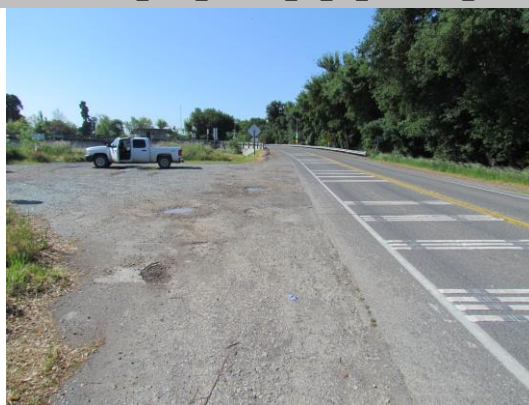
Photo 1 of 1 : SP\_2017\_RD0556\_18\_23\_20170517\_00054.jpg

LM Start	0.16	Rating **	U	Issue No.	23
LM End	1.40	Issue Type +	Ma	Location *	WS
Category	Earthen Levee			GPS Latitude/Longitude	
				Start	End
Item	Vegetation			38.236773 °	38.226925 °
				-121.518112 °	-121.533170 °
DWR ID	DWR_RD0556_01_s_2017_23				
Comment Code					
V1 : Control annual grass and weeds on the levee slopes and easements.					
Inspector Comment					
Control the wild growth from the waterside levee slope beyond the bridge crossing to levee mile 1.40.

Looking downstream from levee mile 0.16 waterside shoulder.

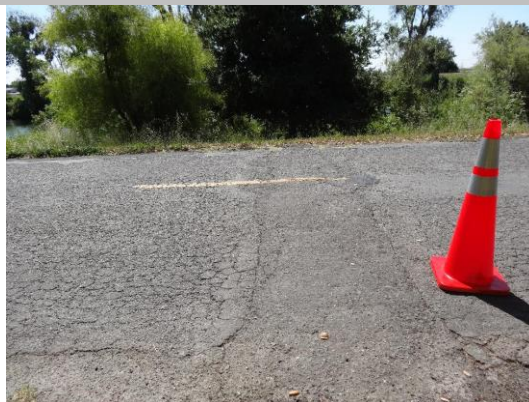
Photo 2 of 3 : UCIP\_SP\_2017\_45664\_74191.jpg

LM Start	0.54	Rating **	M	Issue No.	389
LM End	0.54	Issue Type +	En	Location *	WS
Category	Supplemental			GPS Latitude/Longitude	
				Start	End
Item	DWR UCIP Field Study			38.232354 °	38.232354 °
				-121.521727 °	-121.521727 °
DWR ID					
Comment Code					
Inspector Comment					
FS_ID:45664 DS_ID:20826 EP_NO: 5548A Repair Type: Non-Urgent Crossing Status: Found UCIP Comments: Dense vegetation prevented inspection of WS slope. FIELD_STRUCT_DESC: 14-inch pipe through levee 5.0 feet below the crown. Pole with panel and standpipe on landward toe (5548A- Kay Dix Ranch 1986). FS Date: 5/27/2015

View of WS with cuts visible on pavement.

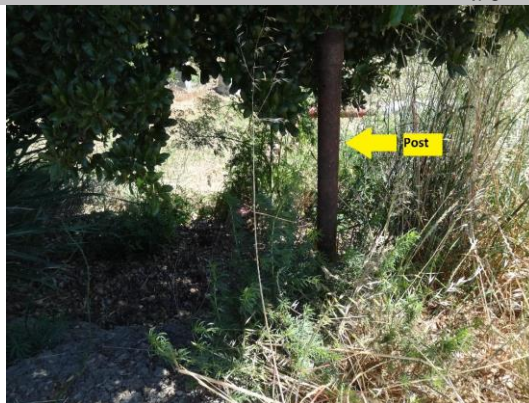
Photo 2 of 3 : UCIP\_SP\_2017\_46799\_74740.jpg

FS\_ID:46799  
DS\_ID:25106  
EP\_NO: N/A  
Repair Type: Non-Urgent  
Crossing Status: Found  
UCIP Comments: Possible erosion above pipe on LS needs attention.  
FIELD\_STRUCT\_DESC: 8-inch steel irrigation pipe unknown feet below crown visible on LS 6 ft away from 10-inch pipe. Post likely for protection of vent located off the crown on shoulder. Electric pole next to pipe on LS.  
FS Date: 5/27/2015

LS view: Post located above pipe on LS slope.

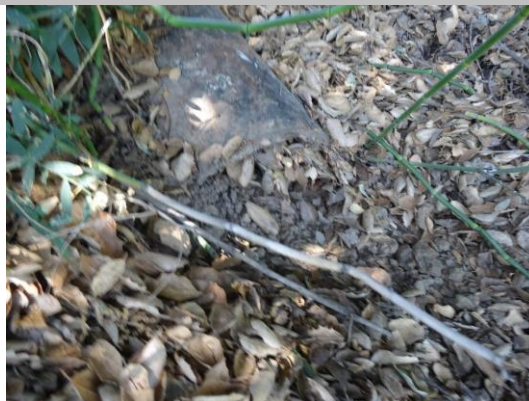
Photo 2 of 3 : UCIP\_SP\_2017\_45683\_74201.jpg

FS\_ID:45683  
DS\_ID:20823  
EP\_NO: 11169  
Repair Type: Non-Urgent  
Crossing Status: Found  
UCIP Comments: Appears abandoned in place and if so should be done so properly. Dense vegetation on WS limits visibility.  
FIELD\_STRUCT\_DESC: 10-inch pipe through levee, 3.8 feet below crown. (Lower end of rock revetment)(ABO 11169 - Mealer and 4848).  
Abandoned in place. O&M Manual Sac 103, June 1954  
FS Date: 5/27/2015

Closeup of abandoned pipe.

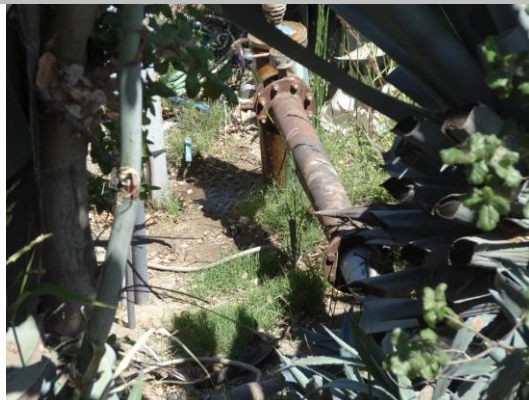
Photo 3 of 3 : UCIP\_SP\_2017\_45692\_74206.jpg

Item	DWR UCIP Field Study			38.227622 °	38.227622 °	
				-121.532154 °	-121.532154 °	
DWR ID						
Comment Code						
Inspector Comment						
FS_ID:45692 DS_ID:20825 EP_NO: 13302 Repair Type: Non-Urgent Crossing Status: Found UCIP Comments: Seal beneath siphon breaker off LS toe leaking. Rodent activity near crown off LS shoulder. Need to contact owner about leaky seal. Dense vegetation prevented inspection of WS slope. FIELD_STRUCT_DESC: 6-inch steel pipe and 2-inch GI electrical conduit through levee 2 feet below crown; roadway with siphon valve on landward shoulder. Concrete stand and pump on landward toe; circuit box also. Cuts visible on pavement. 6-inch PVC standpipe adjacent to pipe off LS toe. (Kay Dix Ranch App. 13302). O&M Manual Sac 103, June 1954 FS Date: 5/27/2015

Closeup of pipe at LS toe. Seal beneath siphon breaker leaking.

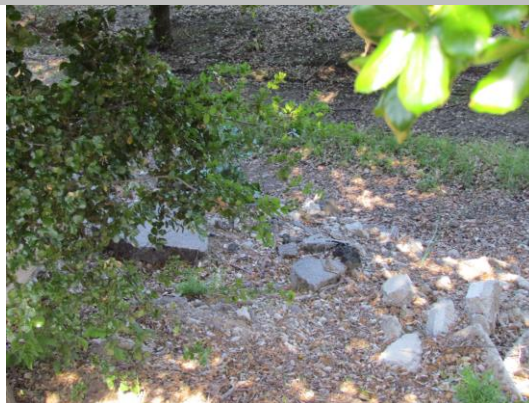
Photo 1 of 3 : SP\_2017\_RD0556\_18\_27\_20170517\_00055.jpg

RD 556 Unit 1 levee mile 1.34-1.37 landside toe.

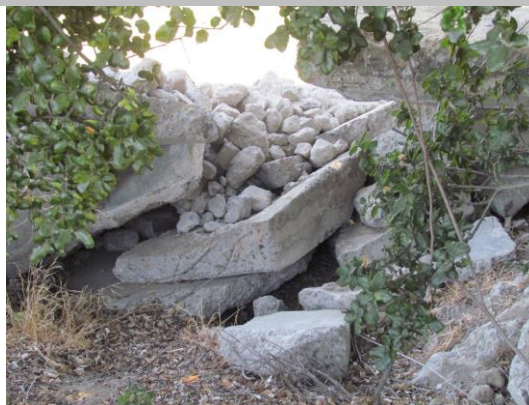
Photo 2 of 3 : SP\_2017\_RD0556\_18\_27\_20170404\_00007.jpg

RD 556 unit 1 levee miles 1.34-1.37 landside toe.

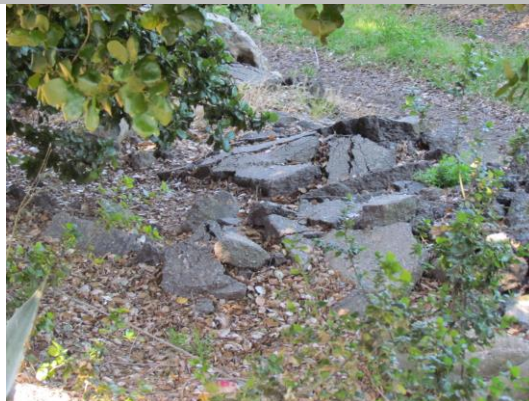
Photo 3 of 3 : SP\_2017\_RD0556\_18\_27\_20170517\_00056.jpg

RD 556 Unit 1 levee mile 1.34-1.37 continuation of material on the toe.

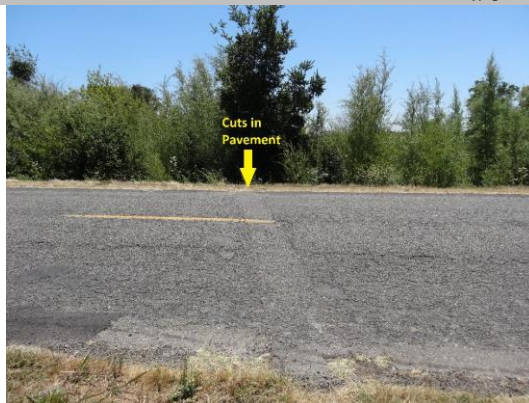
Photo 1 of 3 : UCIP\_SP\_2017\_45746\_74250.jpg

View of WS and cuts in pavement.

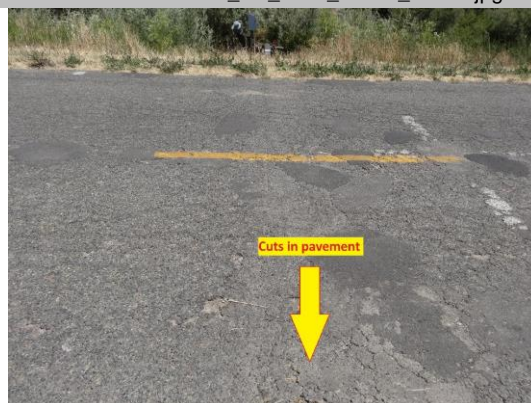
Photo 2 of 3 : UCIP\_SP\_2017\_45786\_74281.jpg

View toward WS with cuts in pavement in alignment with pipe on WS

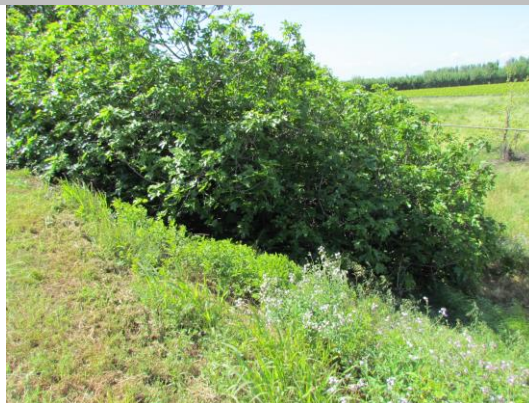
Photo 1 of 1 : SP\_2017\_RD0556\_18\_47\_20170517\_00062.jpg

LM Start	2.38	Rating **	U	Issue No.	47
LM End	2.42	Issue Type +	Ma	Location *	LS
Category	Earthen Levee			GPS Latitude/Longitude	
				Start	End
Item	Vegetation			38.219065 °	38.218458 °
				-121.543855 °	-121.543838 °
DWR ID	DWR_RD0556_01_f_2012_47				
Comment Code					
V7 : Trees / Woody Vegetation					
Inspector Comment					
This section of trees need to be removed from levee section, visibility completely blocked.

RD 556 Unit 1 levee mile 2.38-2.42 landside slope.

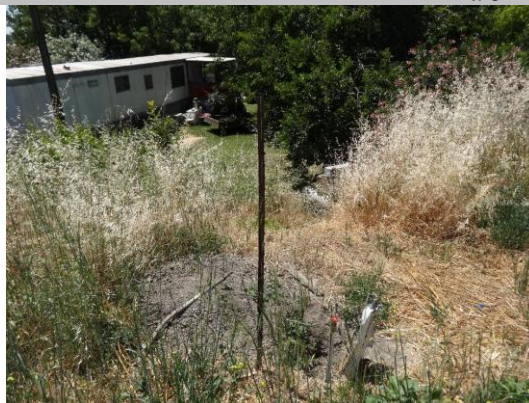
Photo 1 of 3 : UCIP\_SP\_2017\_45803\_74285.jpg

Pipe, pump @LS toe. 2'x2' hole off shoulder. Spigot in hole possibly for irrigation. House and service pole in background.

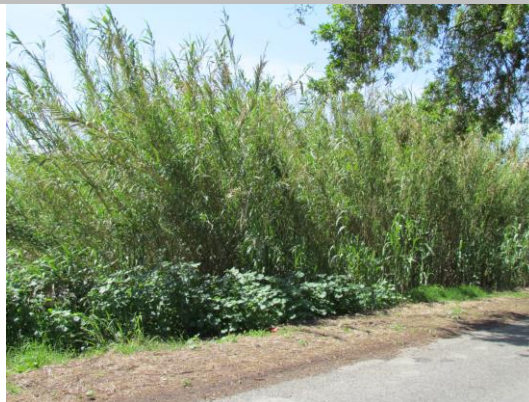
Photo 1 of 1 : SP\_2017\_RD0556\_18\_35\_20170522\_00068.jpg

LM Start	3.12	Rating **	U	Issue No.	35
LM End	3.14	Issue Type +	Ma	Location *	WS
Category	Earthen Levee			GPS Latitude/Longitude	
				Start	End
Item	Vegetation			38.211103 °	38.210970 °
				-121.537993 °	-121.538370 °
DWR ID	DWR_RD0556_01_s_2017_35				
Comment Code					
V2 : Remove the wild growth other than native grasses from the levee slopes.					
Inspector Comment					
Remove the unwanted wild growth from the waterside slope.

RD 556 Unit 1 levee mile 3.12-3.14 waterside shoulder and slope.

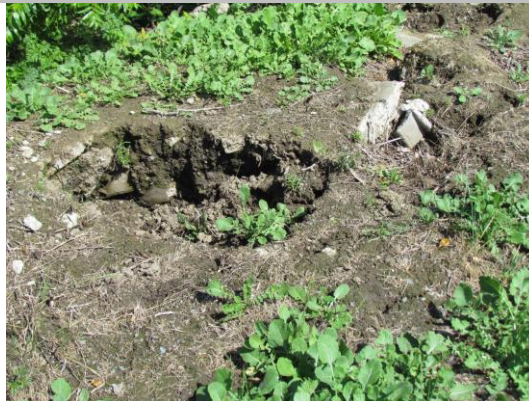
Photo 2 of 2 : SP\_2017\_RD0556\_18\_36\_20170522\_00070.jpg

556 Unit 1 slope erosion levee mile 3.22.

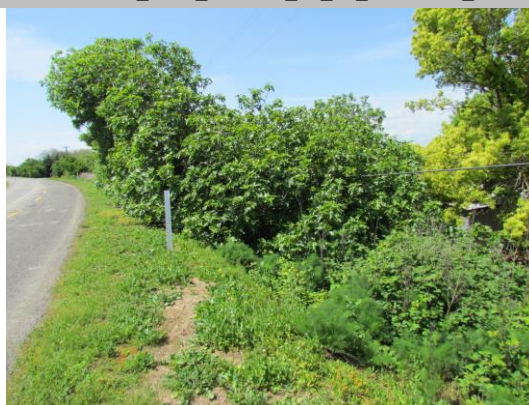
Photo 1 of 1 : SP\_2017\_RD0556\_18\_38\_20170522\_00072.jpg

LM Start	3.25	Rating **	U	Issue No.	38
LM End	3.29	Issue Type +	Ma	Location *	LS
Category	Earthen Levee			GPS Latitude/Longitude	
				Start	End
Item	Vegetation			38.210250 °	38.209842 °
				-121.540207 °	-121.540658 °
DWR ID	DWR_RD0556_01_s_2017_38				
Comment Code					
V7 : Trees / Woody Vegetation					
Inspector Comment					
Remove the wild tree growth and vegetation from the landside levee slope and toe so the ground can be seen.

556 Unit 1 levee mile 3.25-3.29 woody tree growth and vegetation blocking the view of the levee slope and toe.

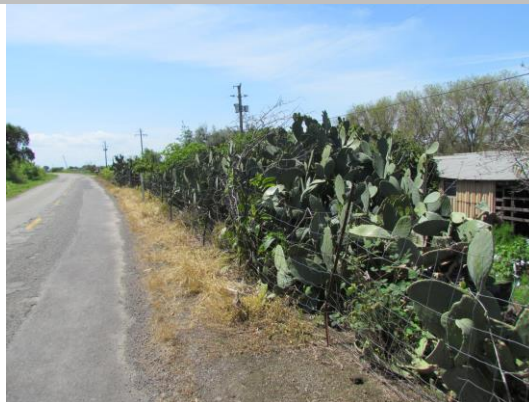
Photo 1 of 1 : SP\_2017\_RD0556\_18\_41\_20170522\_00073.jpg

LM Start	3.42	Rating **	U	Issue No.	41
LM End	5.47	Issue Type +	En	Location *	LS
Category	Earthen Levee			GPS Latitude/Longitude	
				Start	End
Item	Vegetation			38.208113 °	38.186528 °
				-121.541582 °	-121.562450 °
DWR ID	DWR_RD0556_01_s_2017_41				
Comment Code					
V6 : Landscaping					
Inspector Comment					
Remove the wild growth other than annual grasses from the levee slope.

556 Unit 1 levee mile 3.42-5.47 landside shoulder and slope.

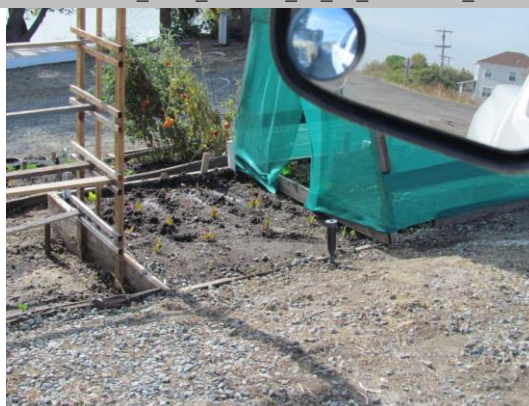
Photo 1 of 2 : SP\_2017\_RD0556\_18\_70\_20170404\_00012.jpg

LM Start	3.94	Rating **	U	Issue No.	70
LM End	4.01	Issue Type +	En	Location *	WS
Category	Earthen Levee			GPS Latitude/Longitude	
				Start	End
Item	Encroachments			38.201515 °	38.201105 °
				-121.542573 °	-121.543720 °
DWR ID	DWR_RD0556_01_f_2014_70				
Comment Code					
CR : Crops					
Inspector Comment					
Remove the unauthorized planter boxes repack earth materials back on slope.

Continue placement of unauthorized planter boxes into levee slope waterside.

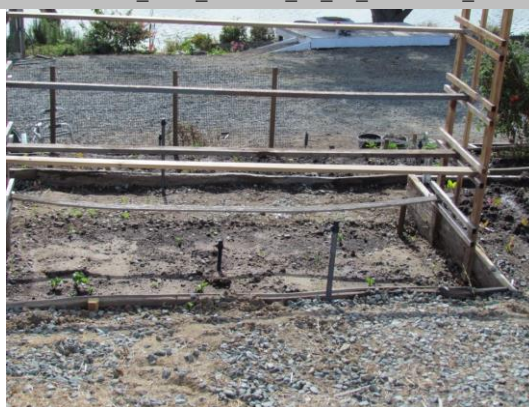
Photo 2 of 2 : SP\_2017\_RD0556\_18\_70\_20170404\_00013.jpg

Landowner has dug into waterward slope and placed planterboxes.

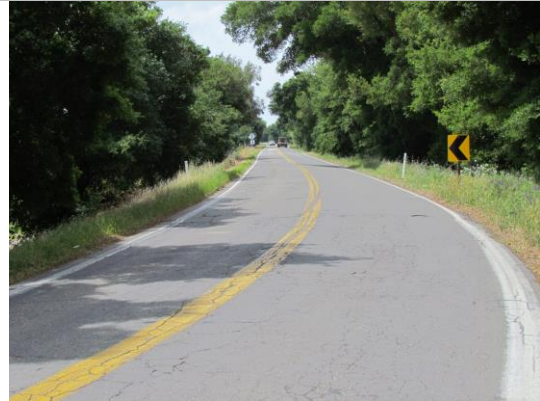
Photo 1 of 1 : SP\_2017\_RD0556\_19\_29\_20170523\_00054.jpg

LM Start	0.00	Rating **	U	Issue No.	29
LM End	5.71	Issue Type +	Ma	Location *	LS
Category	Earthen Levee			GPS Latitude/Longitude	
				Start	End
Item	Vegetation			38.200550 °	38.191937 °
				-121.544190 °	-121.567510 °
DWR ID	DWR_RD0556_02_f_2016_29				
Comment Code					
V1 : Control annual grass and weeds on the levee slopes and easements.					
Inspector Comment					
Control the wild vegetation and wild tree growth from the landside slope and shoulder heading downstream

RD 556 Unit 2 from levee mile 0.00-5.71.

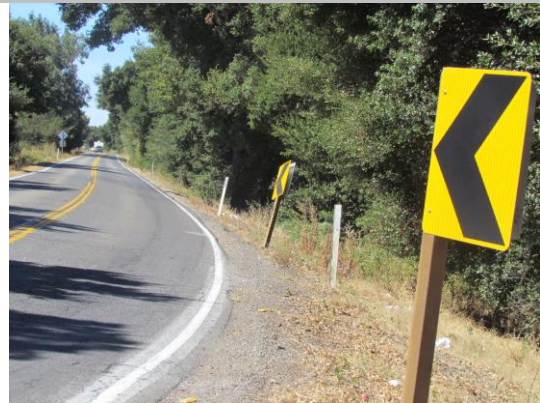
Photo 1 of 1 : SP\_2017\_RD0556\_19\_82\_20170404\_00015.jpg

LM Start	0.00	Rating **	U	Issue No.	82
LM End	5.71	Issue Type +	Ma	Location *	WS
Category	Earthen Levee			GPS Latitude/Longitude	
				Start	End
Item	Vegetation			38.200550 °	38.191937 °
				-121.544190 °	-121.567510 °
DWR ID	DWR_RD0556_02_s_2013_82				
Comment Code					
V2 : Remove the wild growth other than native grasses from the levee slopes.					
Inspector Comment					
Waterside levee slope and shoulder is covered with wild tree growth and other unsatisfactory vegetation.

RD 556 Unit 2 looking downstream of waterside slope.

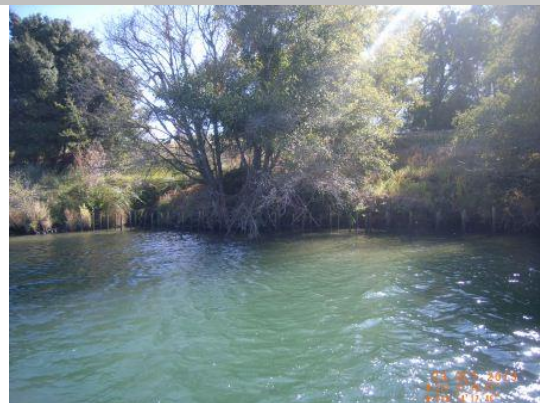
Photo 1 of 1 : SP\_2017\_RD0556\_19\_12\_20170404\_00010.jpg

LM Start	0.31	Rating **	M	Issue No.	12
LM End	0.60	Issue Type +	Ma	Location *	WS
Category	Supplemental			GPS Latitude/Longitude	
				Start	End
Item	2015 USACE Erosion Survey, DRAFT			38.238784 °	38.237862 °
				-121.523932 °	-121.529188 °
DWR ID	DWR_RD0556_02_f_2016_12				
Comment Code					
Inspector Comment					
2002 - Two rocked sections (150 ft long) at the downstream end. 2005 - Lots of old brush boxes, some with established vegetation in the area behind the boxes. 2006 - Some small spots fixed with stone. 2009 - Minimal new erosion, rock in the middle of the reach may be new. 2011 - Minor new erosion at the toe. 2013 - Minor new erosion. 2015: Site is currently under construction. [2015 Site ID: SAC 26-0 L]

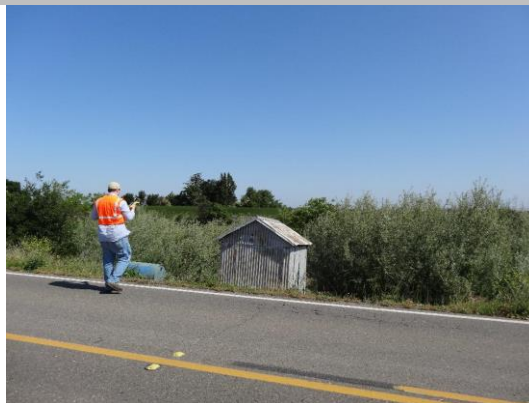
Photo 1 of 3 : UCIP\_SP\_2017\_12512\_20245.jpg

LM Start	0.94	Rating **	M	Issue No.	83
LM End	0.94	Issue Type +	En	Location *	WS
Category	Supplemental			GPS Latitude/Longitude	
				Start	End
Item	DWR UCIP Field Study			38.238125 °	38.238125 °
				-121.535267 °	-121.535267 °
DWR ID					
Comment Code					
Inspector Comment					
FS_ID:12512					
DS_ID:20851					
EP_NO: 11186					
Repair Type: Non-Urgent					
Crossing Status: Found					
UCIP Comments: - a concrete box on LS- water is leaking from priming plastic tank and causing surface erosion on levee slope.					
FIELD_STRUCT_DESC: 4-inch pipe through levee, 4.3-feet below crown. Pump in pump house on berm. Siphon breaker and service pole on landward slope. A concrete spillbox with 3-8-inch openings. (ABO #11186 - Marks). O&M Manual Sac 103, June 1954.					
FS Date: 4/25/2013

WS- pump house on levee berm

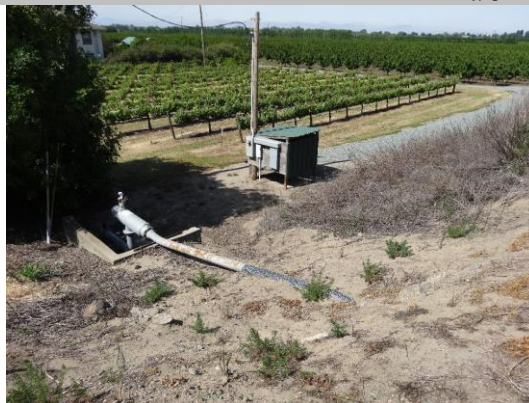
Photo 2 of 3 : UCIP\_SP\_2017\_12512\_20244.jpg

LS- steel pipe on a concrete box

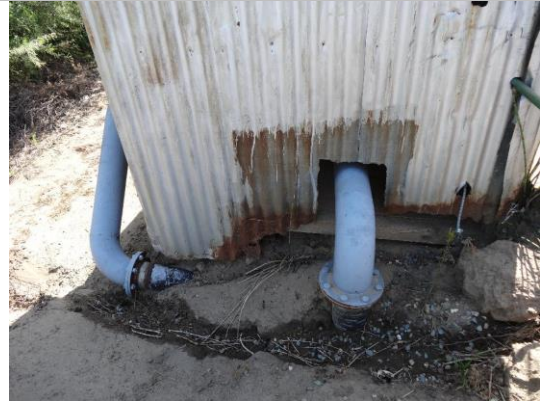
Photo 3 of 3 : UCIP\_SP\_2017\_12512\_20243.jpg

WS- pipe daylight from the pump house.

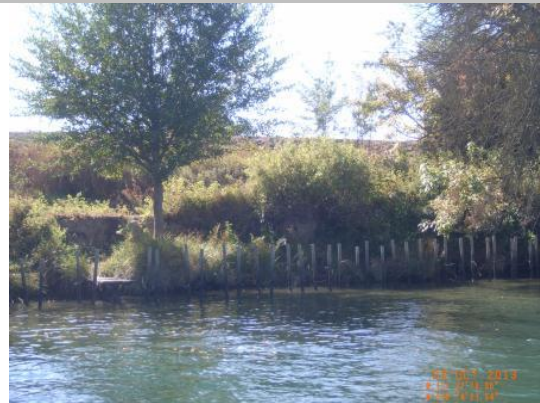
Photo 1 of 1 : SP\_2017\_RD0556\_19\_2\_20170404\_00002.jpg

LM Start	1.03	Rating **	M	Issue No.	2
LM End	1.15	Issue Type +	Ma	Location *	WS
Category	Supplemental			GPS Latitude/Longitude	
				Start	End
Item	2015 USACE Erosion Survey, DRAFT			38.238772 °	38.239265 °
				-121.536788 °	-121.538845 °
DWR ID	DWR_RD0556_02_f_2016_2				
Comment Code					
Inspector Comment					
1997 - Rock is in poor condition and has failed in many places. Scallops in berm with remnants of old rock in the toe area. 2005 - Brush boxes present. 2013 - Site extended upstream approximately 300 ft to include new erosion pockets. 2015: Minor new erosion at toe. [2015 Site ID: SAC_25-2_L]

USACE 2013 Photo #1

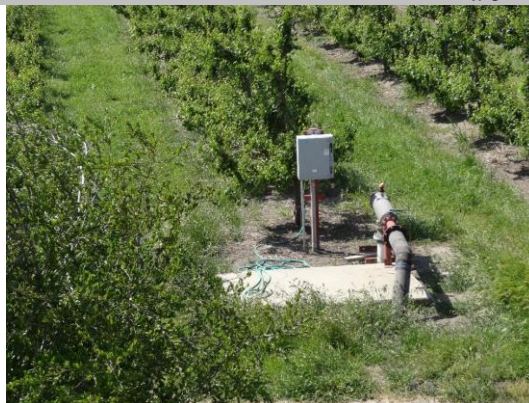
Photo 1 of 3 : UCIP\_SP\_2017\_12573\_20381.jpg

LM Start	1.22	Rating **	M	Issue No.	84
LM End	1.22	Issue Type +	En	Location *	WS
Category	Supplemental			GPS Latitude/Longitude	
				Start	End
Item	DWR UCIP Field Study			38.239327 °	38.239327 °
				-121.540190 °	-121.540190 °
DWR ID					
Comment Code					
Inspector Comment					
FS_ID:12573					
DS_ID:20852					
EP_NO: 11187					
Repair Type: Non-Urgent					
Crossing Status: Found					
UCIP Comments: - gap between 6-inch pipe and 10-inch pipe needs to be sealed.					
FIELD_STRUCT_DESC: A 6-inch steel pipe sleeved through 10-inch pipe through levee, 4.8 feet below crown. Pump on waterside of the levee on river bank. (ABO #11187 Machado).					
FS Date: 4/25/2013

LS- 6-inch steel pipe on orchard.

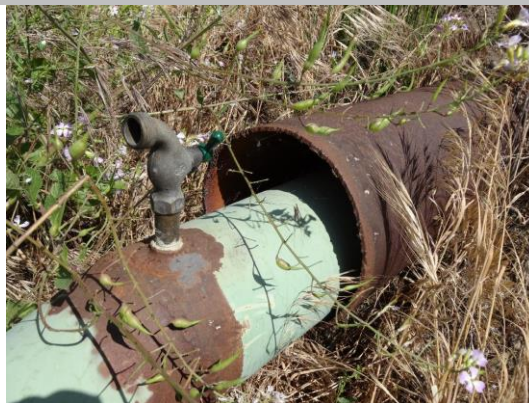
Photo 2 of 3 : UCIP\_SP\_2017\_12573\_20380.jpg

LS- 6-inch steel pipe sleeved through 10-inch steel pipe. 6" pipe is attached with air release valve.

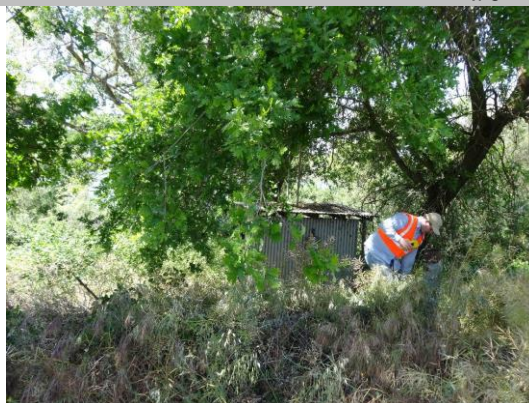
Photo 1 of 3 : UCIP\_SP\_2017\_12574\_20388.jpg

LM Start	2.42	Rating **	M	Issue No.	85
LM End	2.42	Issue Type +	En	Location *	LS
Category	Supplemental			GPS Latitude/Longitude	
				Start	End
Item	DWR UCIP Field Study			38.235261 °	38.235261 °
				-121.558059 °	-121.558059 °
DWR ID					
Comment Code					
Inspector Comment					
FS_ID:12574					
DS_ID:20859					
EP_NO: 11181					
Repair Type: Non-Urgent					
Crossing Status: Found					
UCIP Comments: - Needs to clean CMP riser for proper functioning of siphon breaker.					
FIELD_STRUCT_DESC: A 10-inch steel irrigation pipe through levee, 5.8 feet below crown. Pump and gate valve in pump house on waterward slope. Siphon breaker and service pole on landward slope. (ABO #11181- Collins.). O&M Manual Sac 103, June 1954.					
FS Date: 4/25/2013

WS- pump house on levee berm

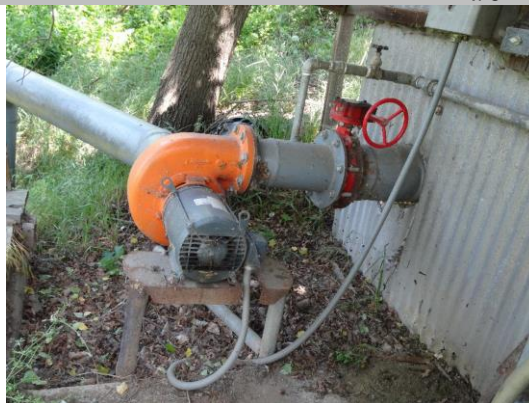
Photo 2 of 3 : UCIP\_SP\_2017\_12574\_20387.jpg

WS- pump, and gate valve in pump house.

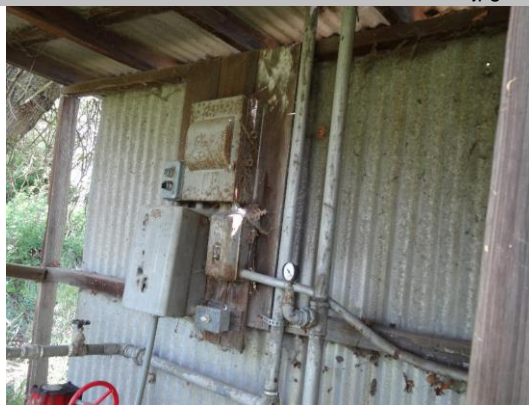
Photo 3 of 3 : UCIP\_SP\_2017\_12574\_20386.jpg

WS- power control panel and electric conduit in pump house.

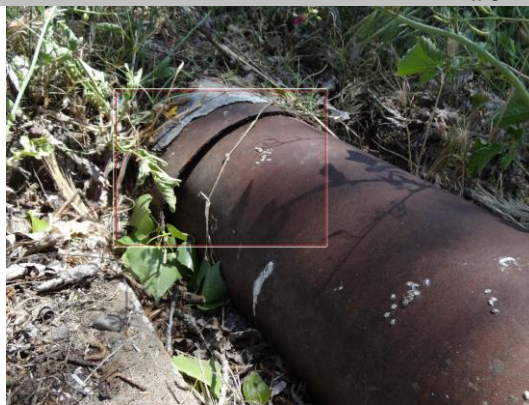
Photo 2 of 3 : UCIP\_SP\_2017\_12525\_20289.jpg

WS- 9-inch pipe sleeved through 10 inch steel pipe.

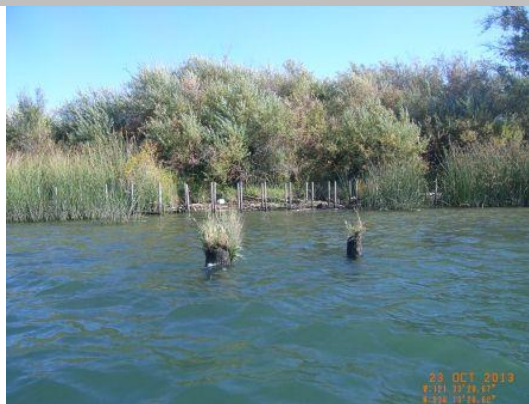
Photo 1 of 1 : SP\_2017\_RD0556\_19\_10\_20170404\_00008.jpg

LM Start	3.17	Rating **	M	Issue No.	10
LM End	3.28	Issue Type +	Ma	Location *	WS
Category	Supplemental			GPS Latitude/Longitude	
				Start	End
Item	2015 USACE Erosion Survey, DRAFT			38.224850 °	38.223233 °
				-121.555641 °	-121.555687 °
DWR ID	DWR_RD0556_02_f_2016_10				
Comment Code					
Inspector Comment					
2000 - Recently fallen cottonwood at the downstream end. 2005 - Empty brush boxes. 2011 - A few trees have fallen since last year. 2012 - Potential new tree popout since last year. 2013 - New erosion at downstream end of site and a recent tree pop-out observed. 2015: No observed changes. [2015 Site ID: SAC_23-2_L]

USACE 2013 Photo #1

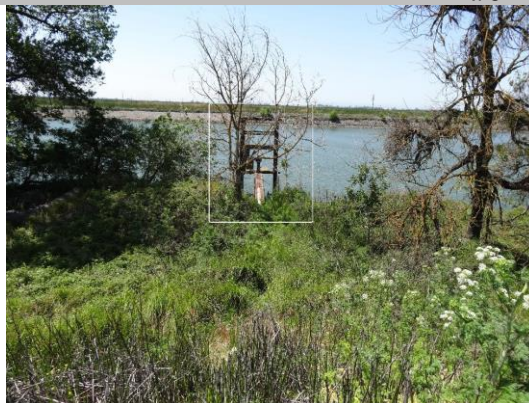
Photo 1 of 3 : UCIP\_SP\_2017\_12527\_20297.jpg

LM Start	3.51	Rating **	M	Issue No.	88
LM End	3.51	Issue Type +	En	Location *	WS
Category	Supplemental			GPS Latitude/Longitude	
				Start	End
Item	DWR UCIP Field Study			38.219851 °	38.219851 °
				-121.556129 °	-121.556129 °
DWR ID					
Comment Code					
Inspector Comment					
FS_ID:12527					
DS_ID:20863					
EP_NO: 11181					
Repair Type: Non-Urgent					
Crossing Status: Found					
UCIP Comments: - needs to fix siphon breaker					
FIELD_STRUCT_DESC: A 10-inch steel irrigation pipe through levee, 4.8 feet below crown. Steel walkway to pump on pile structure in stream. Siphon breaker on waterside and service pole on landward slope. A concrete spillbox with 2-15 inch openings on landside. (ABO # 11181- Collins.). O&M Manual Sac 103, June 1954.					
FS Date: 4/25/2013

WS- pump, pipe, and walkway on steel structure in the stream.

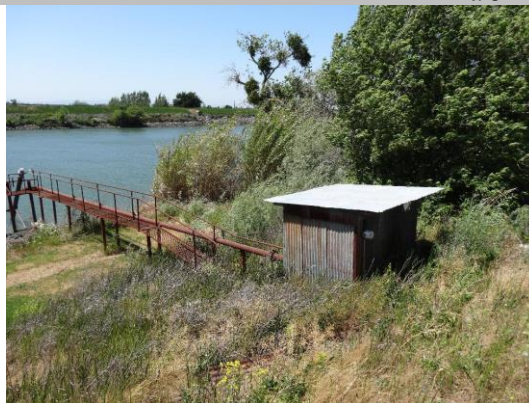
Photo 1 of 3 : UCIP\_SP\_2017\_12543\_20302.jpg

LM Start	3.99	Rating **	M	Issue No.	89
LM End	3.99	Issue Type +	En	Location *	WS
Category	Supplemental			GPS Latitude/Longitude	
				Start	End
Item	DWR UCIP Field Study			38.213031 °	38.213031 °
				-121.556800 °	-121.556800 °
DWR ID					
Comment Code					
Inspector Comment					
FS_ID:12543 DS_ID:20864 EP_NO: 11197 Repair Type: Non-Urgent Crossing Status: Found UCIP Comments: Electric control panel in pump house.Needs cleaning of CMP riser on landside. FIELD_STRUCT_DESC: A 6-inch steel irrigation pipe through levee 6.5 feet below crown. Slanted pump on steel pile structure in the stream, walkway to the pump, and gate valve in pump house on waterward slope. Siphon breaker and service poles on landward slope. Concrete standpipe on landside. (ABO #11197- Souza.). O&M Manual Sac 103, June 1954. FS Date: 4/25/2013

WS- pipe and pump on steel pile structure. Steel walkway from pump house to the pump on steel structure.

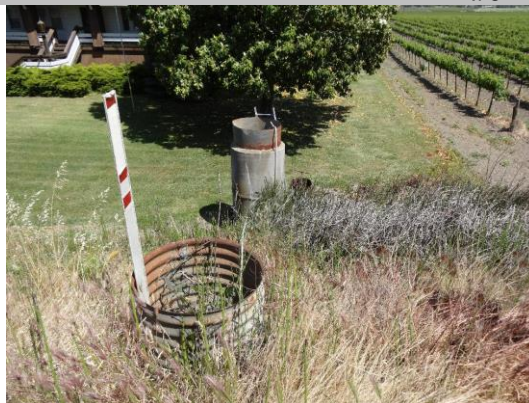
Photo 2 of 3 : UCIP\_SP\_2017\_12543\_20301.jpg

LS- siphon breaker in CMP riser and concrete standpipe behind CMP riser.

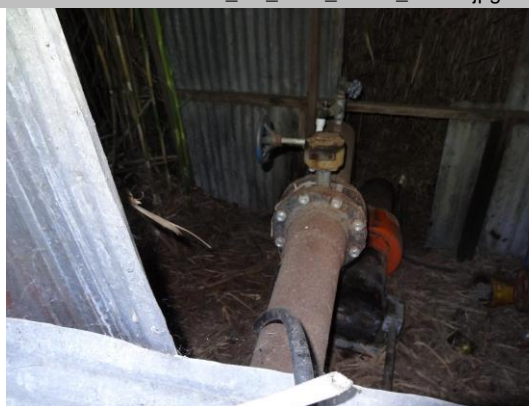
Photo 3 of 3 : UCIP\_SP\_2017\_12545\_20308.jpg

LM Start	4.26	Rating **	M	Issue No.	90 (cont)	
LM End	4.26	Issue Type +	En	Location *	WS	
Category	Supplemental			GPS Latitude/Longitude		
				Start		End
Item	DWR UCIP Field Study			38.209117 °		38.209117 °
				-121.556803 °		-121.556803 °
DWR ID						
Comment Code						
Inspector Comment						
FS_ID:12545 DS_ID:20865 EP_NO: 11194 Repair Type: Non-Urgent Crossing Status: Found UCIP Comments: - CMP riser found abandoned on LS slope. Due to dense vegetation siphon breaker could not be found.- Dense vegetation on both sides of the levee.- Oil leaks from pump set. FIELD_STRUCT_DESC: A 8-inch pipe through levee, 6.7 feet below crown. Pump and gate valve in pump house on waterward slope. Siphon breaker on landward slope. (ABO #11194- Robinson.). O&M Manual Sac 103, June 1954. FS Date: 4/25/2013

WS- pump, gate valve and pipe in pump house.

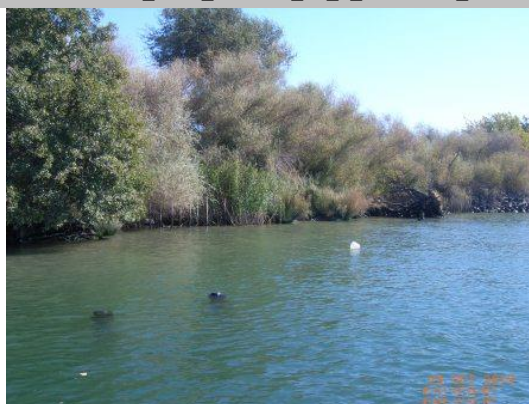
Photo 1 of 1 : SP\_2017\_RD0556\_19\_7\_20170404\_00006.jpg

LM Start	4.45	Rating **	M	Issue No.	7
LM End	4.49	Issue Type +	Ma	Location *	WS
Category	Supplemental			GPS Latitude/Longitude	
				Start	End
Item	2015 USACE Erosion Survey, DRAFT			38.206377 °	38.205729 °
				-121.557184 °	-121.557108 °
DWR ID	DWR_RD0556_02_f_2016_7				
Comment Code					
Inspector Comment					
2013 - Erosion pockets encroaching on levee foundation. 2015: No observed changes. [2015 Site ID: SAC_21-9_L]

USACE 2013 Photo #1

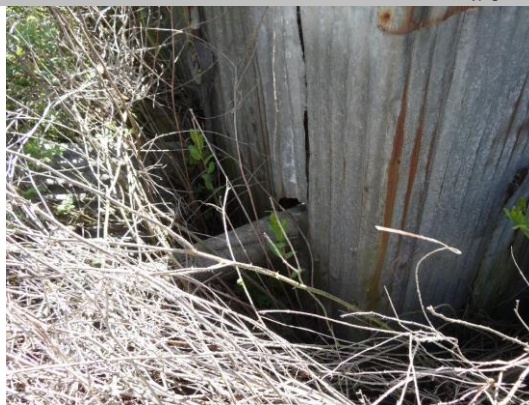
Photo 2 of 3 : UCIP\_SP\_2017\_12546\_20313.jpg

LM Start	4.54	Rating **	M	Issue No.	91
LM End	4.54	Issue Type +	En	Location *	WS
Category	Supplemental			GPS Latitude/Longitude	
				Start	End
Item	DWR UCIP Field Study			38.204974 °	38.204974 °
				-121.556789 °	-121.556789 °
DWR ID					
Comment Code					
Inspector Comment					
FS_ID:12546 DS_ID:20866 EP_NO: 11940 Repair Type: Non-Urgent Crossing Status: Found UCIP Comments: - Abandoned crossing.- Siphon breaker on LS not found due to dense vegetation, - An abandoned CMP riser and service pole found on LS.- It may need to be properly abandoned. FIELD_STRUCT_DESC: Abandoned 6-inch pipe through levee, 6.7 feet below crown. Pump and gate valve in pumphouse on waterward slope. Siphon breaker and service pole on landward slope. (ABO # 11940-Robinson.). O&M Manual Sac 103, June 1954. FS Date: 4/25/2013

WS- pipe daylight from levee slope to pump house.

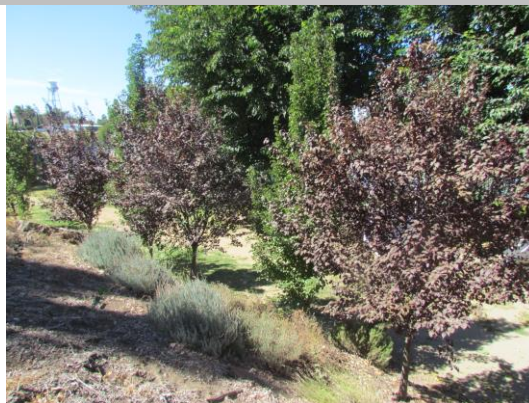
Photo 1 of 2 : SP\_2017\_RD0556\_19\_27\_20170404\_00011.jpg

LM Start	4.65	Rating **	U	Issue No.	27
LM End	4.65	Issue Type +	En	Location *	WS
Category	Earthen Levee			GPS Latitude/Longitude	
				Start	End
Item	Encroachments			38.203425 °	38.203425 °
				-121.556845 °	-121.556845 °
DWR ID	DWR_RD0556_02_s_2017_27				
Comment Code					
TR : Tree or limb					
Inspector Comment

RD 556 Unit 2 levee mile 2.16-2.19 waterside toe of slope.

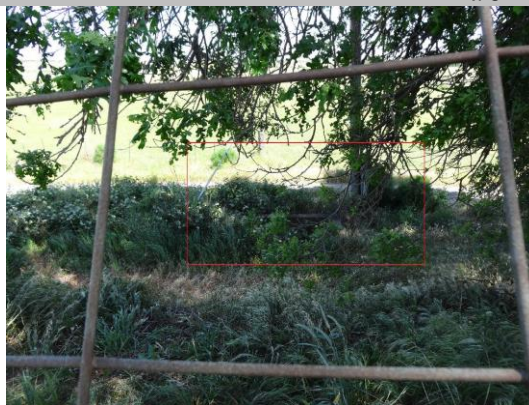
Photo 2 of 3 : UCIP\_SP\_2017\_12547\_20319.jpg

LM Start	4.73	Rating **	M	Issue No.	92
LM End	4.73	Issue Type +	En	Location *	WS
Category	Supplemental			GPS Latitude/Longitude	
				Start	End
Item	DWR UCIP Field Study			38.202301 °	38.202301 °
				-121.556952 °	-121.556952 °
DWR ID					
Comment Code					
Inspector Comment					
FS_ID:12547					
DS_ID:20867					
EP_NO: 11199					
Repair Type: Non-Urgent					
Crossing Status: Indicator Found					
UCIP Comments: - pump, gate valve and pumphouse not found on waterward slope.- an abandoned electric control panel found on WS.- may need to be properly abandoned.					
FIELD_STRUCT_DESC: A 6-inch steel irrigation pipe through levee, 6.5 feet below crown. Siphon and concrete spill box with 2- 8 inch openings. (ABO #11199- Tokoyoshi.). O&M Manual Sac 103, June 1954.					
FS Date: 4/25/2013

LS- concrete distribution box near levee toe.

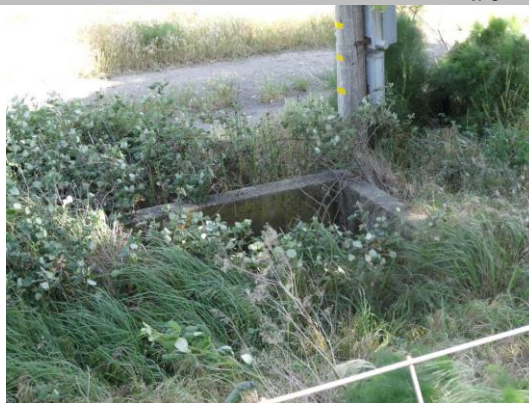
Photo 3 of 3 : UCIP\_SP\_2017\_12547\_20318.jpg

LM Start	4.73	Rating **	M	Issue No.	92 (cont)
LM End	4.73	Issue Type +	En	Location *	WS
Category	Supplemental			GPS Latitude/Longitude	
				Start	End
Item	DWR UCIP Field Study			38.202301 °	38.202301 °
				-121.556952 °	-121.556952 °
DWR ID					
Comment Code					
Inspector Comment					
FS_ID:12547 DS_ID:20867 EP_NO: 11199 Repair Type: Non-Urgent Crossing Status: Indicator Found UCIP Comments: - pump, gate valve and pumphouse not found on waterward slope.- an abandoned electric control panel found on WS.- may need to be properly abandoned. FIELD_STRUCT_DESC: A 6-inch steel irrigation pipe through levee, 6.5 feet below crown. Siphon and concrete spill box with 2- 8 inch openings. (ABO #11199- Tokoyoshi.). O&M Manual Sac 103, June 1954. FS Date: 4/25/2013

LS- power pole and a concrete distribution box near levee toe.

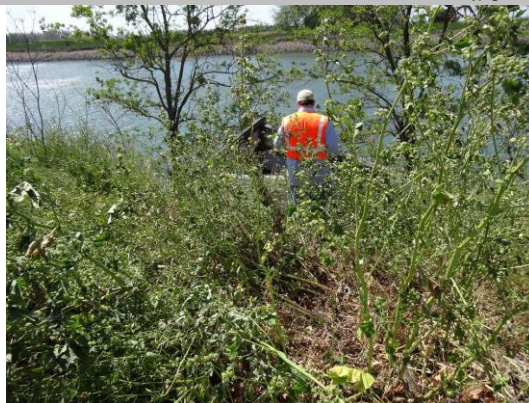
Photo 1 of 3 : UCIP\_SP\_2017\_12564\_20347.jpg

FS\_ID:12564  
DS\_ID:20868  
EP\_NO: 11191  
Repair Type: Non-Urgent  
Crossing Status: Found  
UCIP Comments: - needs to fix CMP riser.  
FIELD\_STRUCT\_DESC: A 8-inch pipe through levee, 5.7 feet below crown. Pump on waterward slope, gate valve on berm. Siphon breaker and service pole on landward slope. (ABO #11191-Pacific Fruit Exchange.)  
FS Date: 4/25/2013

WS- pump house on levee slope.

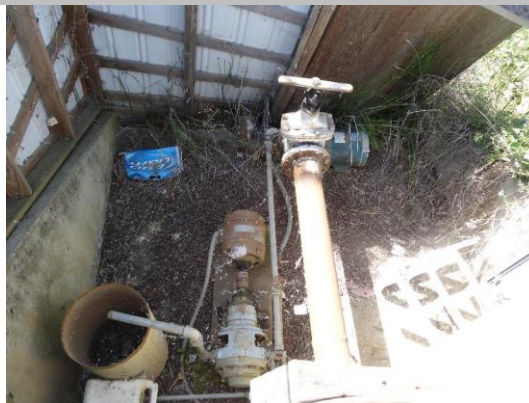
Photo 2 of 3 : UCIP\_SP\_2017\_12564\_20346.jpg

WS- pump, pipe and gate valve in pump house.

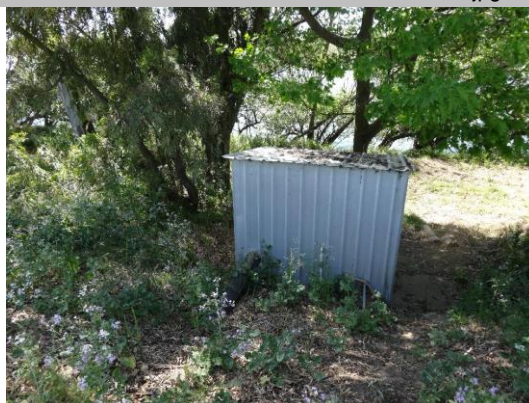
Photo 1 of 3 : UCIP\_SP\_2017\_12570\_20364.jpg

LM Start	5.21	Rating **	U	Issue No.	94
LM End	5.21	Issue Type +	En	Location *	WS
Category	Supplemental			GPS Latitude/Longitude	
				Start	End
Item	DWR UCIP Field Study			38.195755 °	38.195755 °
				-121.560078 °	-121.560078 °
DWR ID					
Comment Code					
Inspector Comment					
FS_ID:12570 DS_ID:20869 EP_NO: 11185 Repair Type: Urgent Crossing Status: Found UCIP Comments: Large pit and erosion on WS levee berm. FIELD_STRUCT_DESC: A 8-inch pipe through levee, 5.7 feet below crown. Pump and gate valve in pumphouse on waterward slope. Siphon breaker, concrete box, and service pole on landward slope. (ABO # 11185- Langhart.) FS Date: 4/25/2013

WS- pump house on levee slope

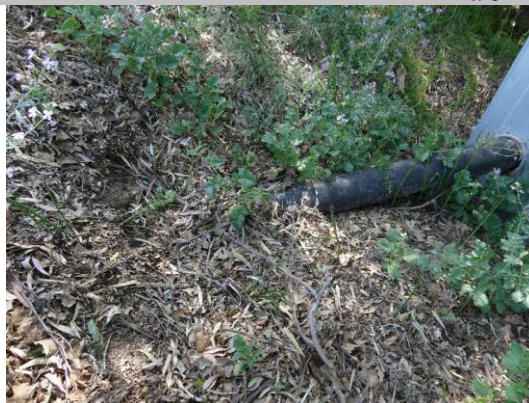
Photo 2 of 3 : UCIP\_SP\_2017\_12570\_20363.jpg

LM Start	5.21	Rating **	U	Issue No.	94 (cont)	
LM End	5.21	Issue Type +	En	Location *	WS	
Category	Supplemental			GPS Latitude/Longitude		
				Start	End	
Item	DWR UCIP Field Study			38.195755 °	38.195755 °	
				-121.560078 °	-121.560078 °	
DWR ID						
Comment Code						
Inspector Comment						
FS_ID:12570 DS_ID:20869 EP_NO: 11185 Repair Type: Urgent Crossing Status: Found UCIP Comments: Large pit and erosion on WS levee berm. FIELD_STRUCT_DESC: A 8-inch pipe through levee, 5.7 feet below crown. Pump and gate valve in pumphouse on waterward slope. Siphon breaker, concrete box, and service pole on landward slope. (ABO # 11185- Langhart.) FS Date: 4/25/2013

WS- pipe daylight from the levee.

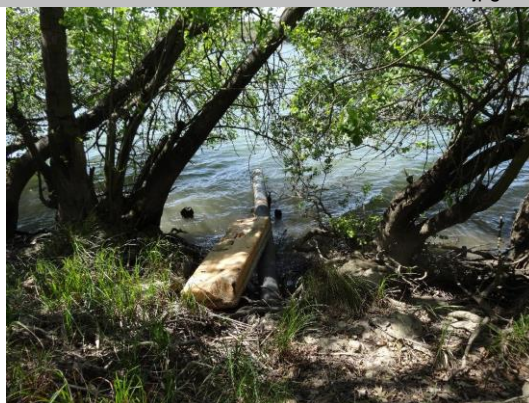
Photo 3 of 3 : UCIP\_SP\_2017\_12570\_20367.jpg

WS- intake pipe in the stream.

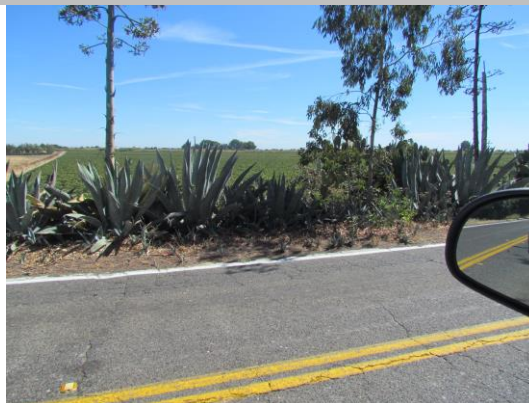
Photo 1 of 1 : SP\_2017\_RD0556\_19\_31\_20170404\_00014.jpg

LM Start	5.40	Rating **	M	Issue No.	31
LM End	5.44	Issue Type +	En	Location *	LS
Category	Earthen Levee			GPS Latitude/Longitude	
				Start	End
Item	Vegetation			38.193760 °	38.193445 °
				-121.562458 °	-121.562895 °
DWR ID	DWR_RD0556_02_s_2012_31				
Comment Code					
V6 : Landscaping					
Inspector Comment					
Control the wild growth within the landscaping. This choice of plant has taken over the levee slope and shoulder making it imposible to view the slope and ground.

RD 556 Unit 2 levee mile 5.40-5.44 landside levee shoulder and slope looking downstream.
